# Klamath National Forest

## **Best Management Practices Water Quality Evaluation Program Monitoring Report 2003**

# Klamath National Forest 2003

## Best Management Practices (BMP)

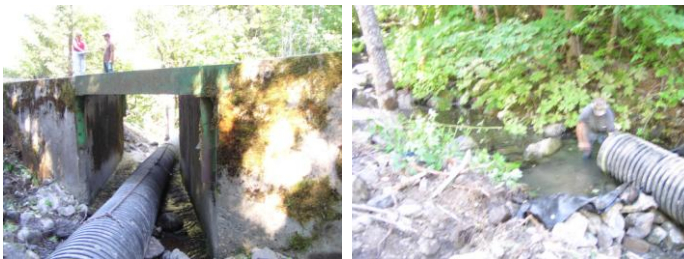
### **McNeal Creek Fish Passage Dewatering**

Review of the McNeal Creek fish passage site (10N04 road) on September 19, 2003 found that the dewatering of the site met all implementation criteria. The minor amount of turbidity noted downstream was from the construction crew positioning the inlet pipe.

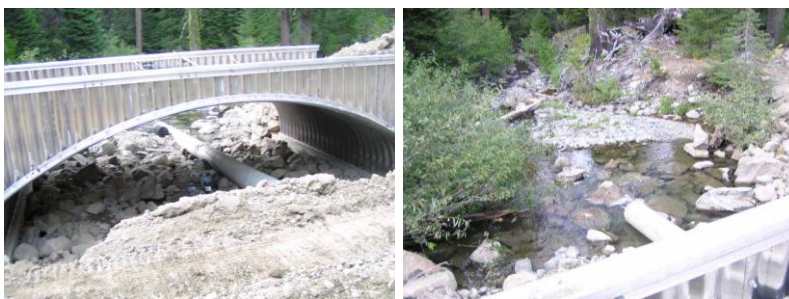
### **Upper South Fork Scott River Fish Passage Dewatering**

Review of the Upper South Fork Scott fish passage site (40N17 road) on September 19, 2003 found that the dewatering of the river was effective and the water was running clear downstream.

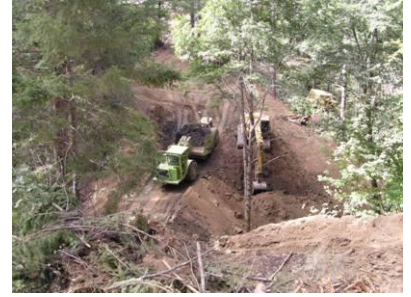
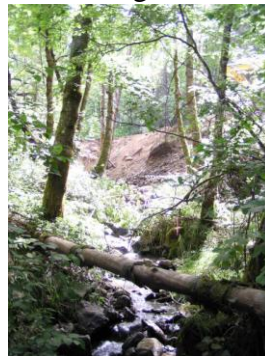
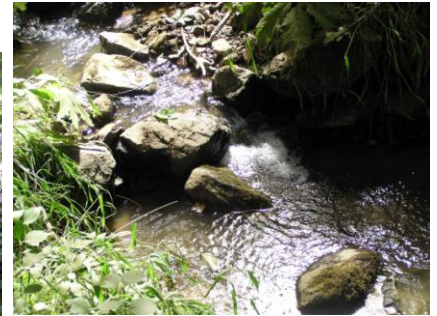
## King Solomon Mine Sediment Dam Restoration In-Stream Construction

In-stream construction was monitored on September 16, 2003. At this time, the remnant dam abutment across the Matthews Creek channel was being excavated and removed. A temporary stream crossing was constructed to access the area. The creek crossing was built with a culvert and rock fill, and about 25 feet of soil fill over the rock.

The creek water was running slightly turbid about 75 feet downstream of where the excavator was working to remove the dam. After the dam abutment was removed, the temporary crossing was also removed.

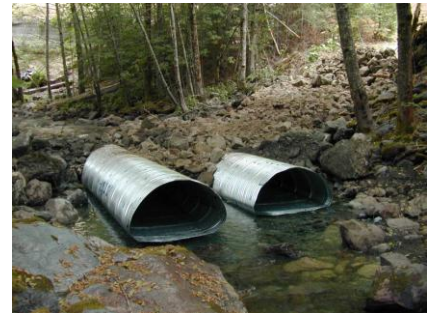
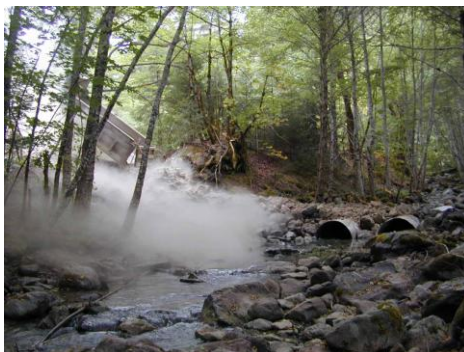
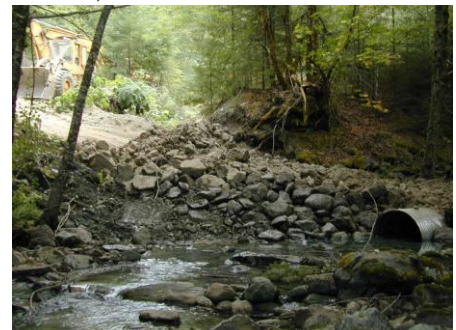
## Siskon Mine Rehabilitation Phase I, In-Stream Construction

In-stream construction was reviewed on October 3, 2003. A vented rock ford was constructed across Copper Creek to provide access to the mine area. The crossing was designed to maintain fish passage during low flows, and to allow high water to pass over the crossing without causing sedimentation during the winter storm flows. During construction, the project contract inspector noted that several large boulders had to be removed from the stream bottom to allow the twin 49" X 30" and 30 foot long corrugated metal pipes (CMPs) to fit one foot below the stream bottom. After the pipes were placed, about 15 cubic yards of class V riprap was placed on top of the pipes. In addition, six inches of one inch minus washed gravel was placed over geotextile fabric as a travel surface.

Stream

turbidity was noted during placement of the CMPs,

but it was of short duration and was not noticeable more than 300 feet downstream. This crossing will be in place for about 2 years and will be removed when clean up of the mine is completed.

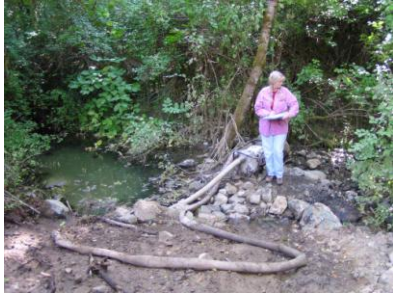
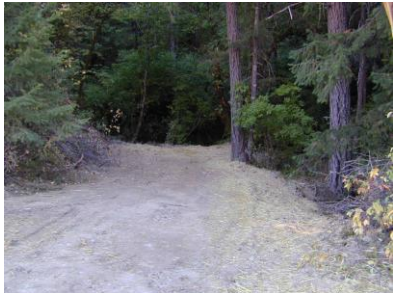
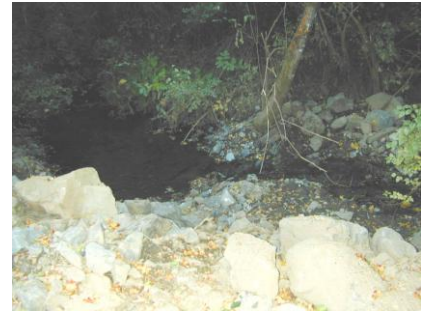
### King Solomon Mine Sediment Dam Restoration Water Source Development

The water source along the 38N17 road at M.P. 1.75 was reviewed during the project on September 19, 2003 and after project completion on October 10, 2003. The water source met most of the implementation requirements. BMPs were described in the environmental document and guidelines were established for water withdrawal, and stream bank alteration was minimized to provide the water source. The area was an old water source that had not been used for a long time. Fish were observed in the

pool, and the intake was screened appropriately. The minor problems were that sediment and rock (less than a cubic yard) was placed in the channel to construct the water source pool, instead of just rock, there was some rill erosion leading to the stream from where the hose is connected to the water truck, and the road

access was rutted due to the absence of aggregate surfacing. At

the end of the project, the all of the sediment and rocks were removed from the channel, the channel bank was armored with riprap, and the disturbed areas off of the road way were mulched and seeded.

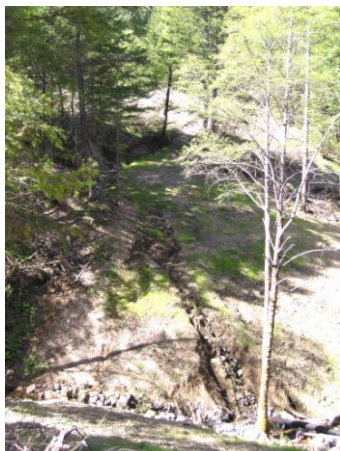
### King Solomon Mine Sediment Dam Restoration, Winter-Spring Monitoring, 2004

Project monitoring of the King Solomon project over the winter and spring of 2004 documented several small shallow debris flows on the west slope where the upper dam remnant was removed. Removal of the dam material allowed an existing spring line to surface in the restored slope. The spring line formed a gully delivering about 8 cubic yards of sediment into the stream with several more cubic yards stored in the channel. The stream down cut a couple of feet to the original base level and the creek migrated about 8 feet into the restored slope. Mitigation measures are to hand place additional riprap along the

revegetate and stabilize. The other problem noted was that road use during fall and winter by woodcutters has damaged the road, leaving large ruts. The road was outsloped using material from the dams. The road will be graded and surfaced with aggregate this summer. Additional effectiveness monitoring will occur over the whole project site in 2004.

channel and at the mouth of the gully to retard stream bank erosion while vegetation is becoming established on the slope. The dewatering pipe will also be removed. Additional grass seed, mulch, or other vegetation may also be placed on the erosion site if needed during the summer. Additional riprap was hand placed along the stream bank on the other side of the channel before the rainy season of 2004, and there were no erosion problems noted. Over the next couple of years, both restored slopes will
